## Australia – Victoria

No. – 207 (T) - 2022

PORT MELBOURNE OUTER ANCHORAGE  
BEACON CHARTED INCORRECTLY**Date:** 01 June 2022**Refers:** NA.**Details:** Mariners are advised that, Outer Anchorage Beacon in position 37° 57.008' S 144° 51.429' E is charted incorrectly.

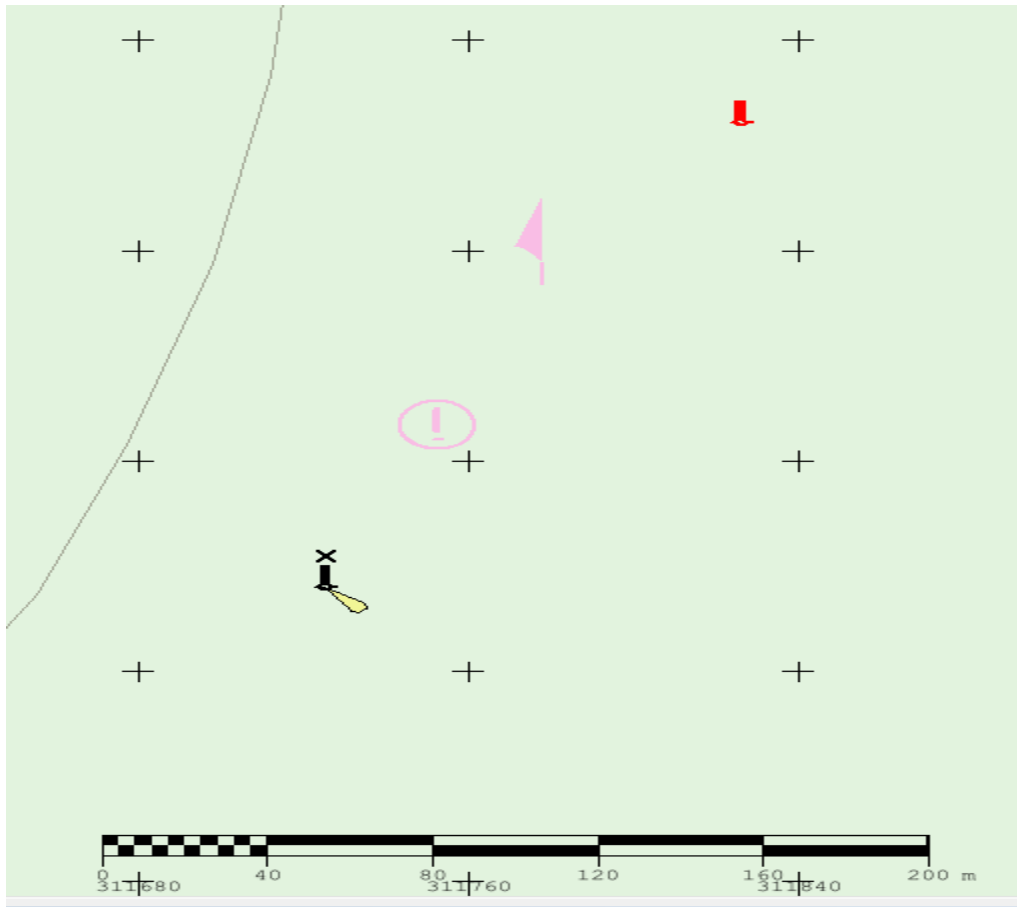
The beacon is lying immediately to the northeast of its present charted position

The image below shows the currently charted ENC position in “**Black**”, and the position of the same beacon as surveyed in “**Red**”.

Buoy	Characteristic	Actual Position
Yellow Beacon	Fl (4) .12s 10m 3M	37° 56'.914 S 144° 51' .500”.

**Charts &  
Publications  
affected** ENC AU5MEL01**Further  
notice:** No further Notice will be issued

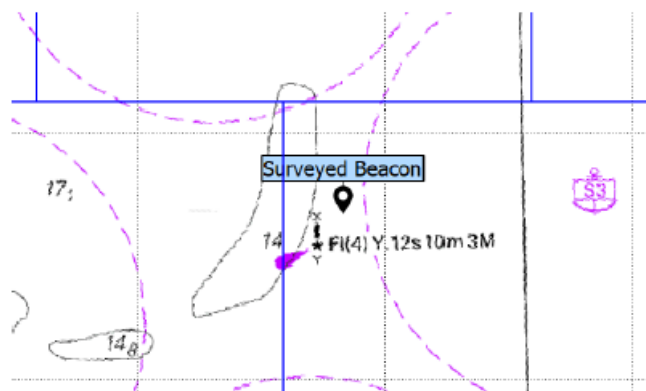
Location:

Easting	Northing
ENC	311721.80	5797554.07
Surveyed	311826.02	5797728.86
Diff	-104.22	-174.79
